**FIELD ACTIVITIES REPORT
Mine Adit Entry**

**RED AND BONITA MINE SITE
Silverton, San Juan County, Colorado**

TDD No. 1008-01

January 20, 2012

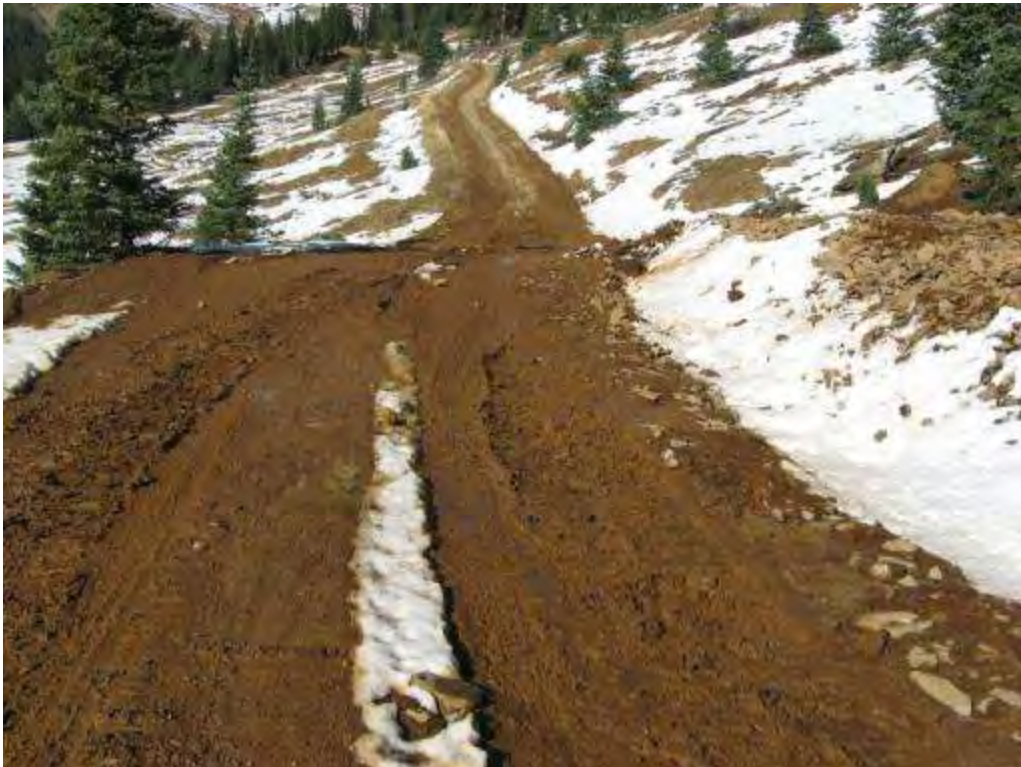
PHOTO 1 8-23-2011

Field conditions prior to adit entry activities. South view along CR 53. Toe of dump on left. See also Photo 2.

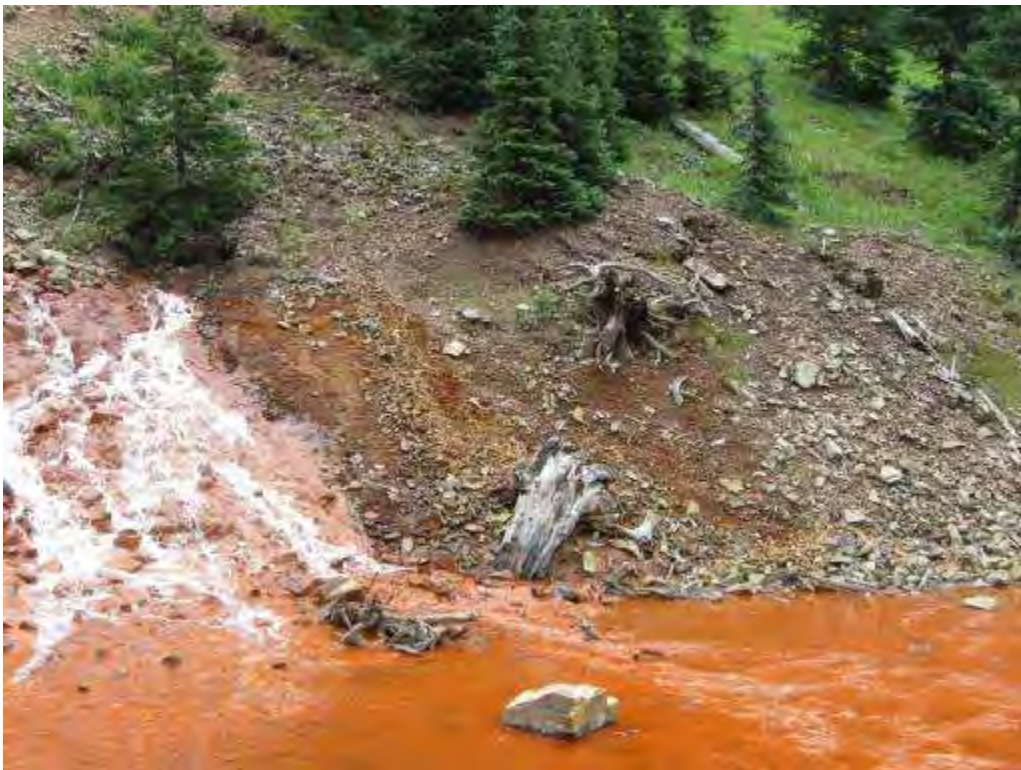
PHOTO 12 8-24-2011

Field conditions prior to adit entry activities. AMD flowing from mountain side at apparent adit location.

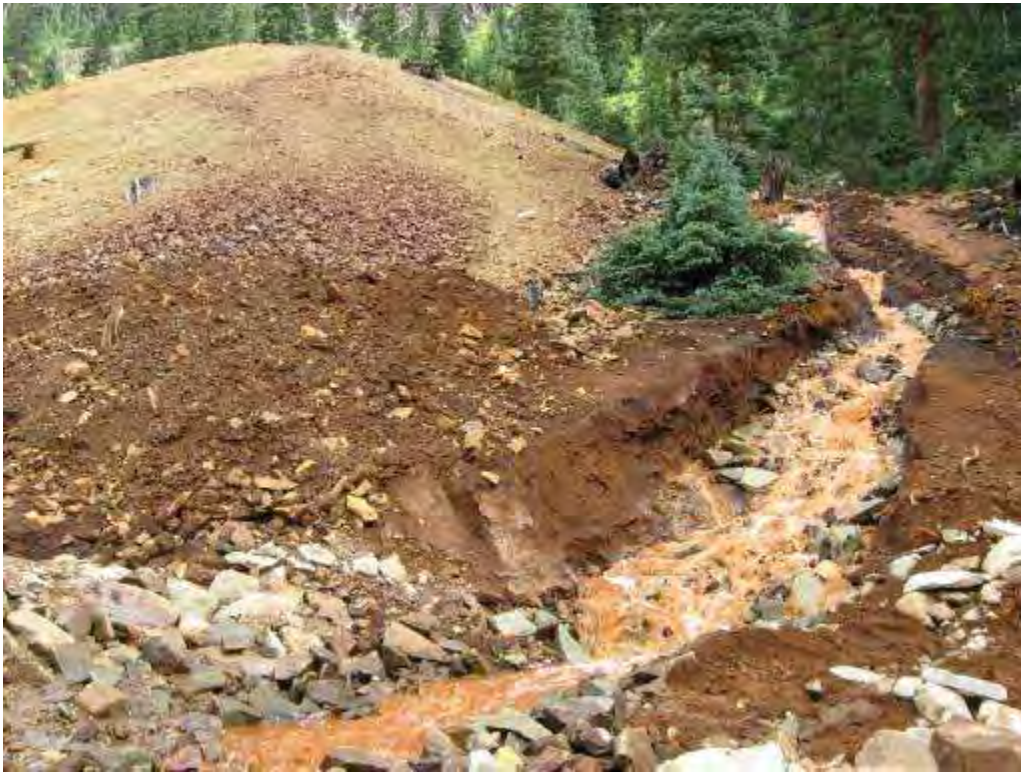
PHOTO 13 8-29-2011

Initial diversion flow from adit into south ditch. Red color derived from ditch sediments washing out.

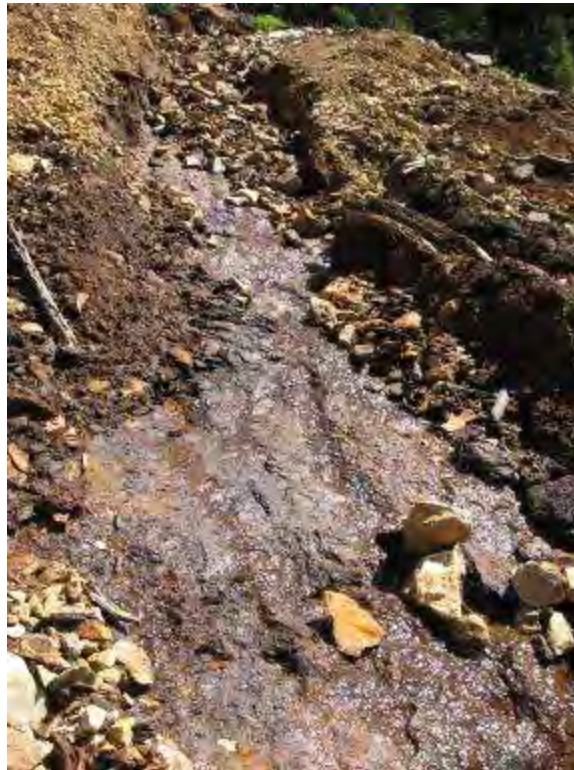
PHOTO 14 8-30-2011

South ditch flow temporarily diverted. Red-colored resistant ferricrete underlying thin soil and dump material.

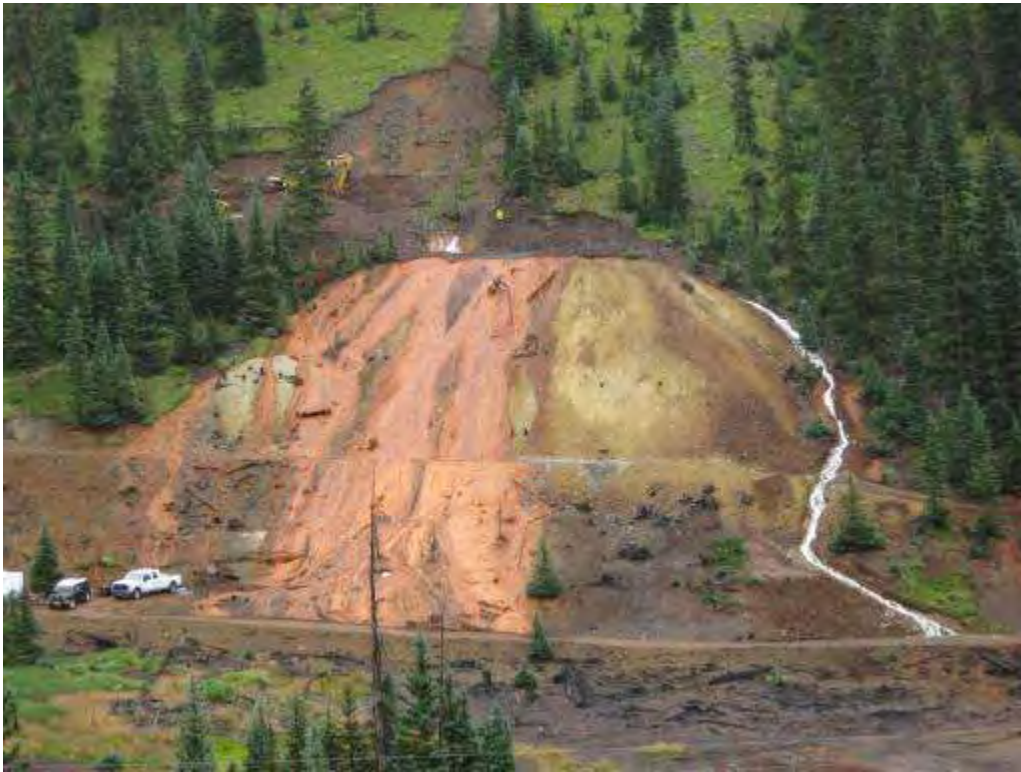
PHOTO 19 9-6-2011

Red and Bonita Mine. AMD cascading down portal collapse at top left of dump into the south ditch on right. Red and Bonita Mill debris in area on left side of dump above vehicles.

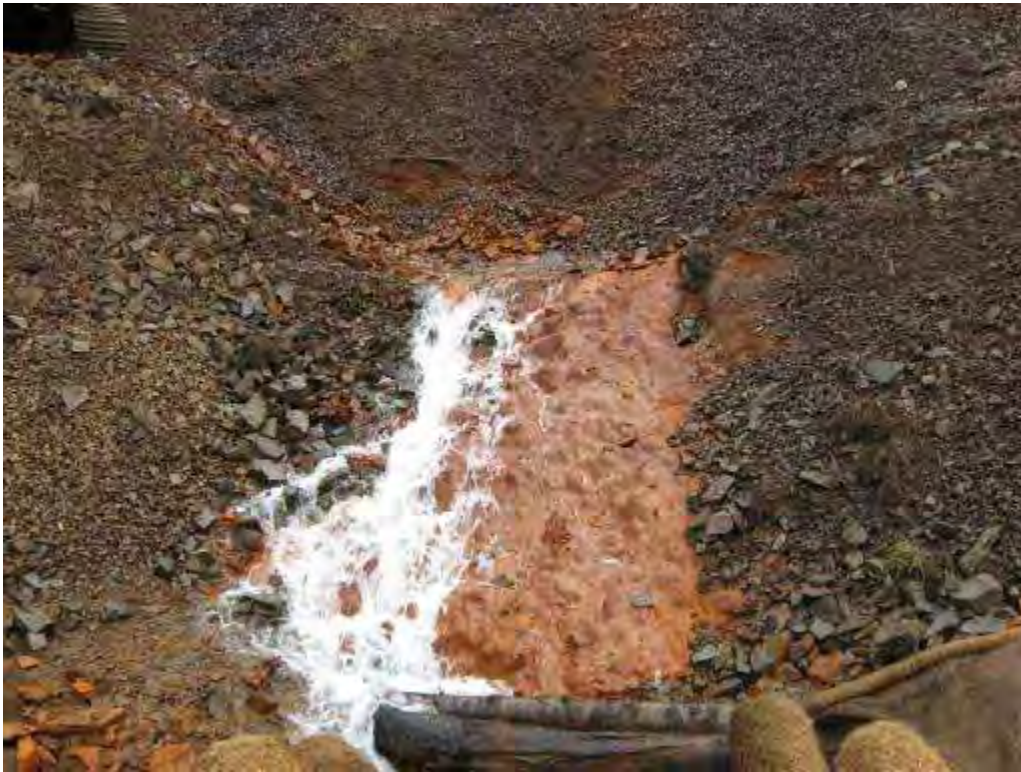
PHOTO 25 9-11-2011

During excavation activities, AMD effluent water was observed to flow through the collapsed material from a distinct upper horizontal limit, as determined by yellow boy staining. This upper limit line coincided with the current adit flow, and was later discovered to coincide with some of the rail spiling. Upon additional excavation it was determined that AMD effluent water was releasing from the adit at the roof elevation. The mine adit outline was eventually observed to be easily distinguished from the mountainside and was encountered within a few horizontal feet of the slope surface (Photo 30). The adit entrance was discovered to be contained within a resistant ferricrete formation of undetermined thickness and lateral extent. Apparently, because of the steep 44 percent slope, loose talus material was able to slide down-slope over an unknown number of years to collapse and fill the mine portal area.

Excavated approximately 3 feet of collapsed talus material from portal area. Note yellow boy-coated talus material and small piece of horizontal lagging at yellow boy horizon.

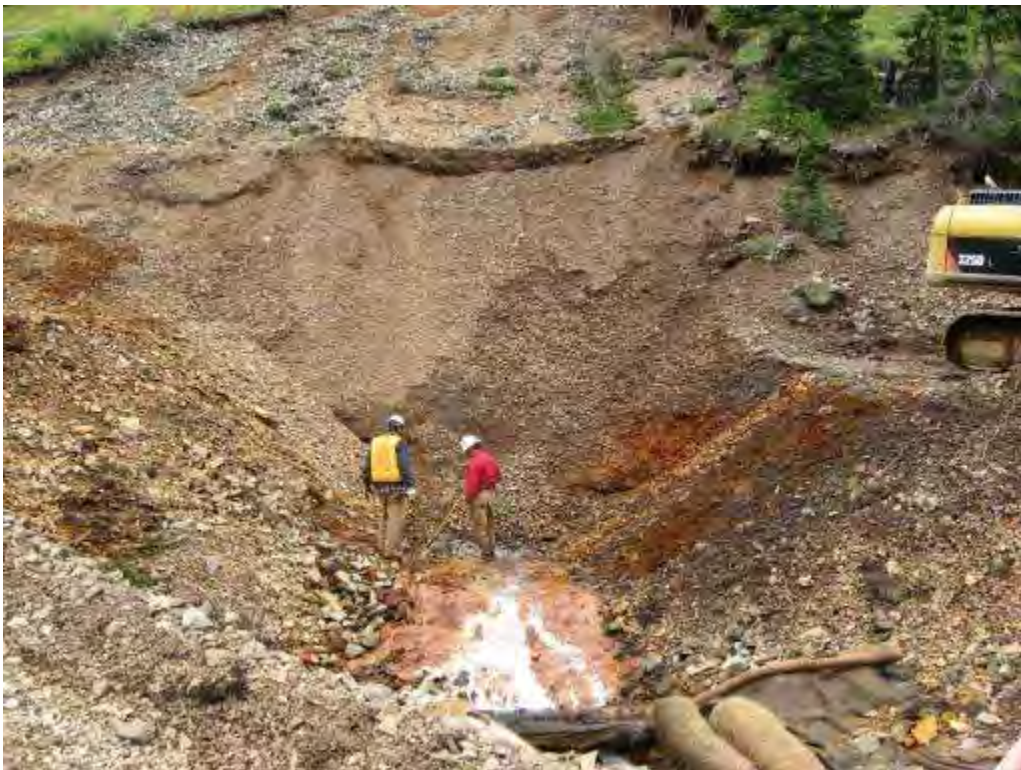
PHOTO 28 9-13-2011

Collapsed portal work area. Removed approximately 6 feet of talus material from in front of adit to level where workman is standing. Top of red staining at dig face indicates upper AMD flow level. Note talus sloughing due to steep slope.

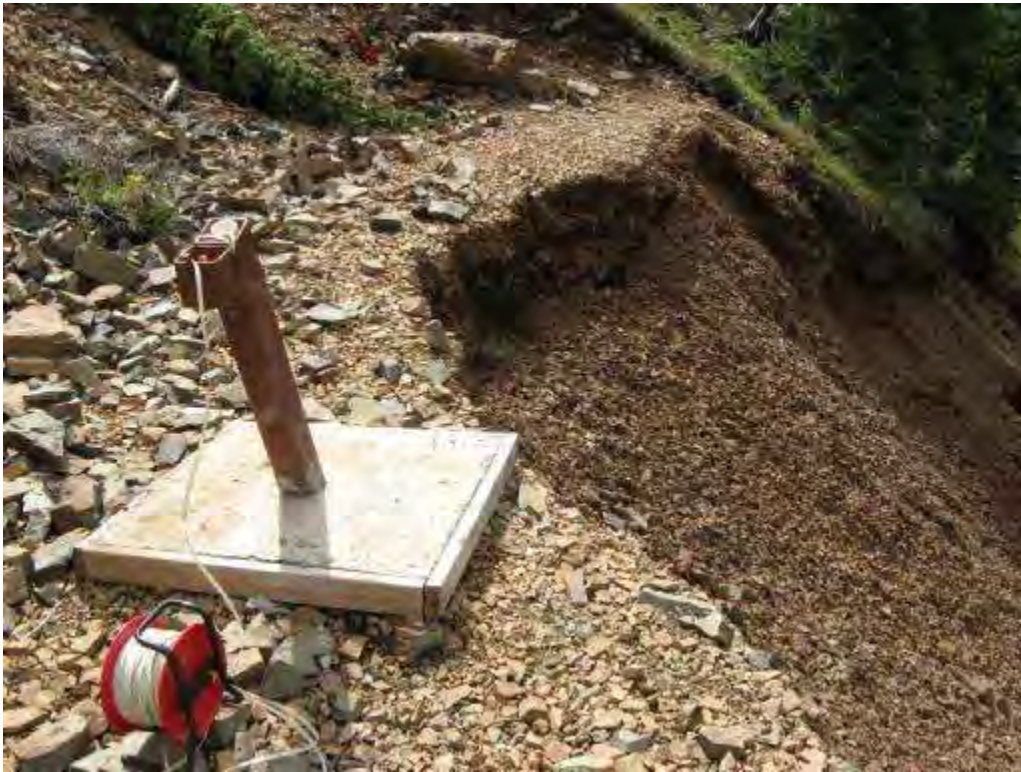
PHOTO 29 9-13-2011

Slope failure at bench above excavation area at collapsed portal. Note water level indicator tool in well.

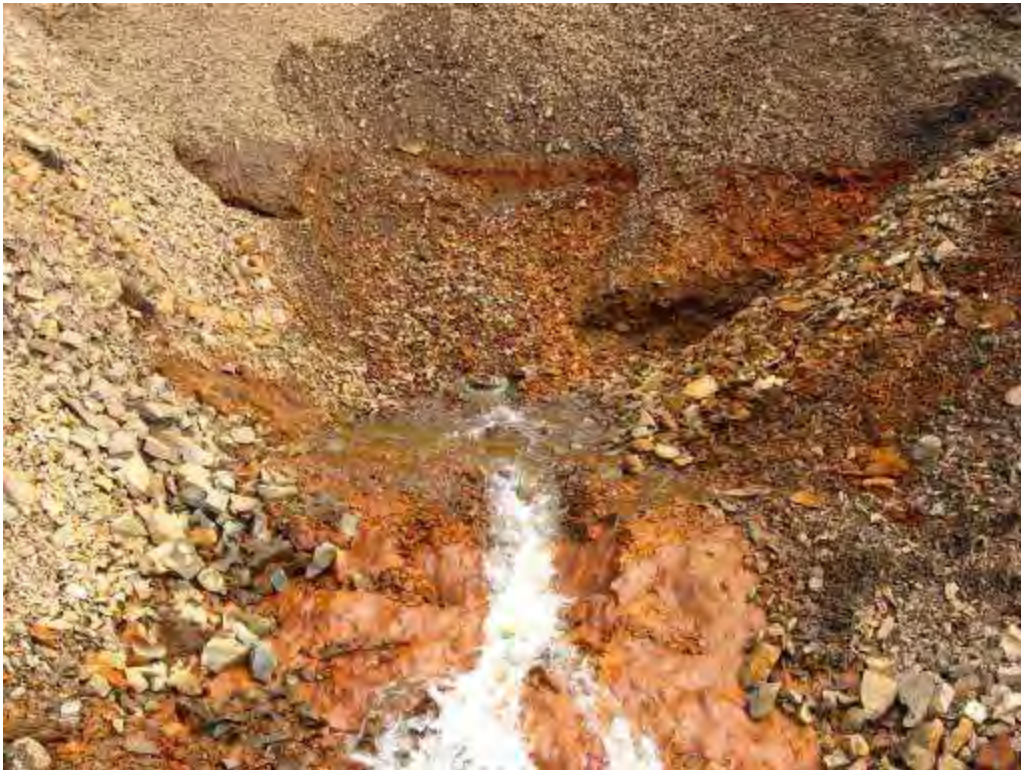
PHOTO 30 9-13-2011

Collapsed portal work area. Dark red ferricrete formation becoming apparent at dig face, visible above right of AMD outflow. Line of red staining in photo top indicates AMD flow level and deposition of yellow boy.

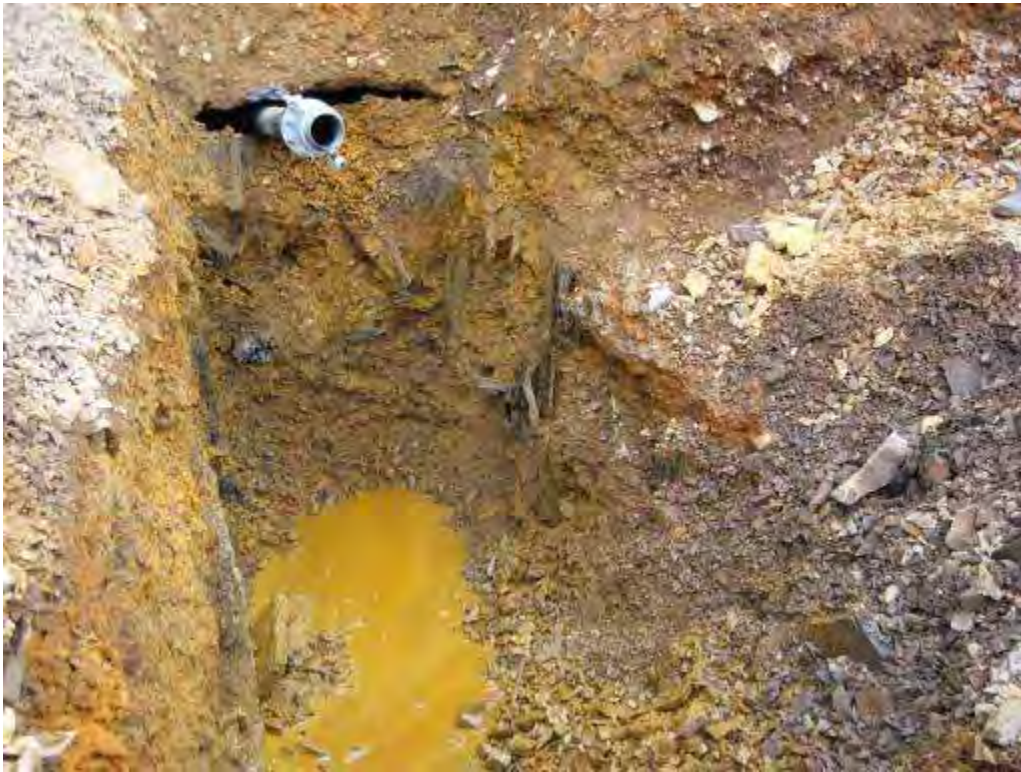
PHOTO 37 9-27-2011

Invert of adit on solid ferricrete formation under standing water in photo. Note wood debris. Portion of red ferricrete wall visible on right of excavation.

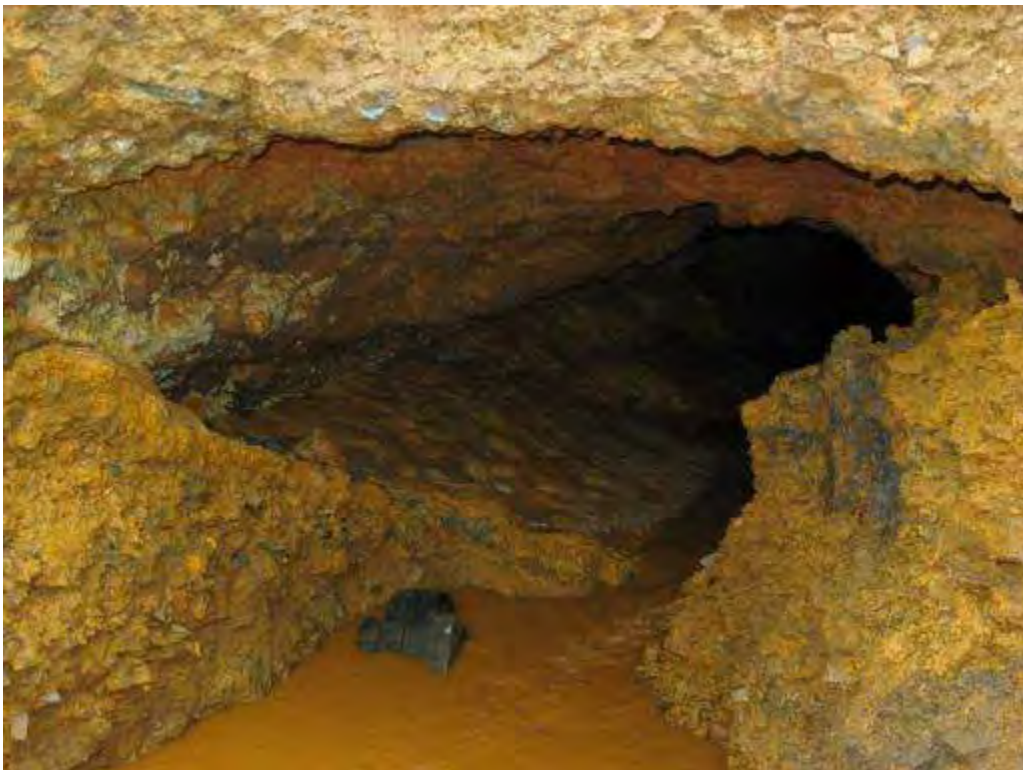
PHOTO 40 9-29-2011
Left rib of adit. Abundant collapse/fines/yellow boy material.

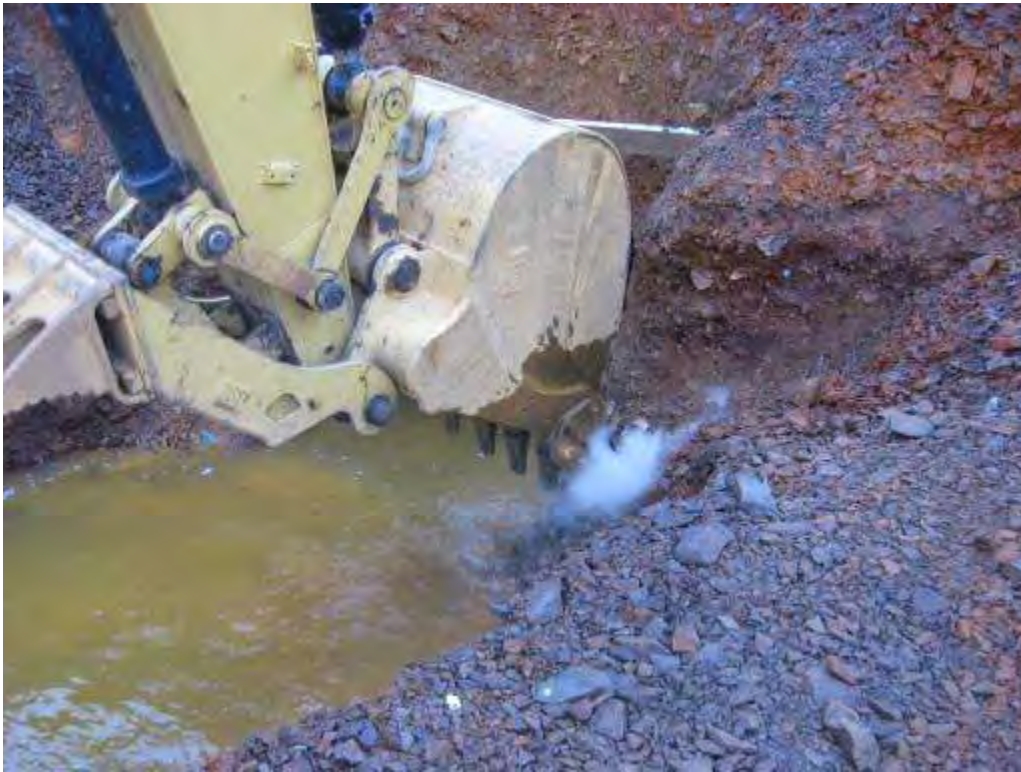
PHOTO 41 9-30-2011

In order to install the new corrugated galvanized metal culvert portal structure as closely to the adit opening as possible, a minor amount of ferricrete had to be broken from the outwardly sloping side walls using the excavator. The ferricrete was very hard and difficult to break from the mountainside (Photo 41). A 10-foot horizontal section of 10-foot diameter culvert pipe was placed to within approximately 3 feet of the top of the sloping ferricrete adit entrance, although the lower half of the culvert pipe fit snugly against the ferricrete rock face where it had been broken out (Photo 42). Douglas fir timber roof supports were bridged from the top of the metal culvert to the ferricrete rock face and covered with loose talus material. A wood timber set was also placed under the roof support at the ferricrete rock face for added support (Photo 43). An additional 5-foot section of galvanized metal culvert pipe was also spliced to the original 10-foot section for a final portal length of 15 feet, leaving sufficient area to access the remaining dump pad. The portal structure rests on a ferricrete floor and, therefore, could not be lowered.

Excavator having difficulty breaking well-cemented ferricrete rock from portal face to accommodate new portal structure.

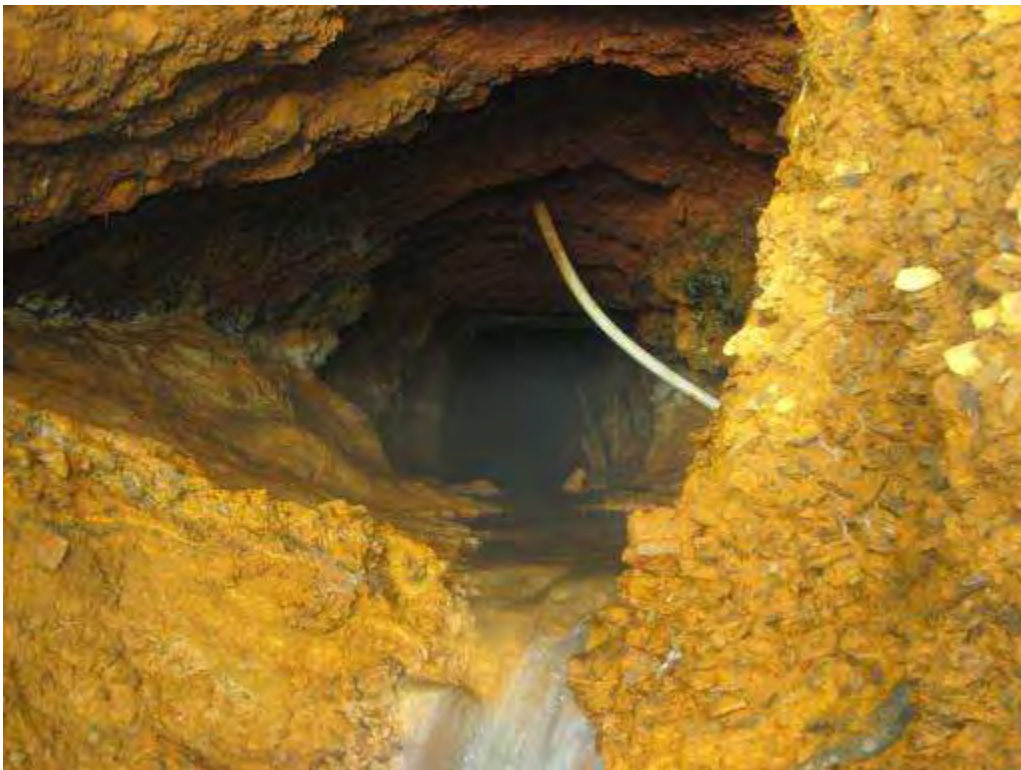
the adit floor at the entrance, and the fines are suspected to become thinner with further entry into the adit, as the adit floor is declined to promote outward water flow. Approximately 4 feet of void space was measured from the fines on the floor to the adit roof. A timber set is observed an estimated 80 feet inby, as well as remnant material including a wood wedge still intact on the right rib near the entrance (Photo 44).

PHOTO 44 10-11-2011
View into adit from portal. Sediment material on floor in photo foreground is 2 feet thick, approximately 4 feet of open space to adit back. AMD water draining down center. PVC monitoring well pipe is visible in adit. Note timber set visible behind PVC well.

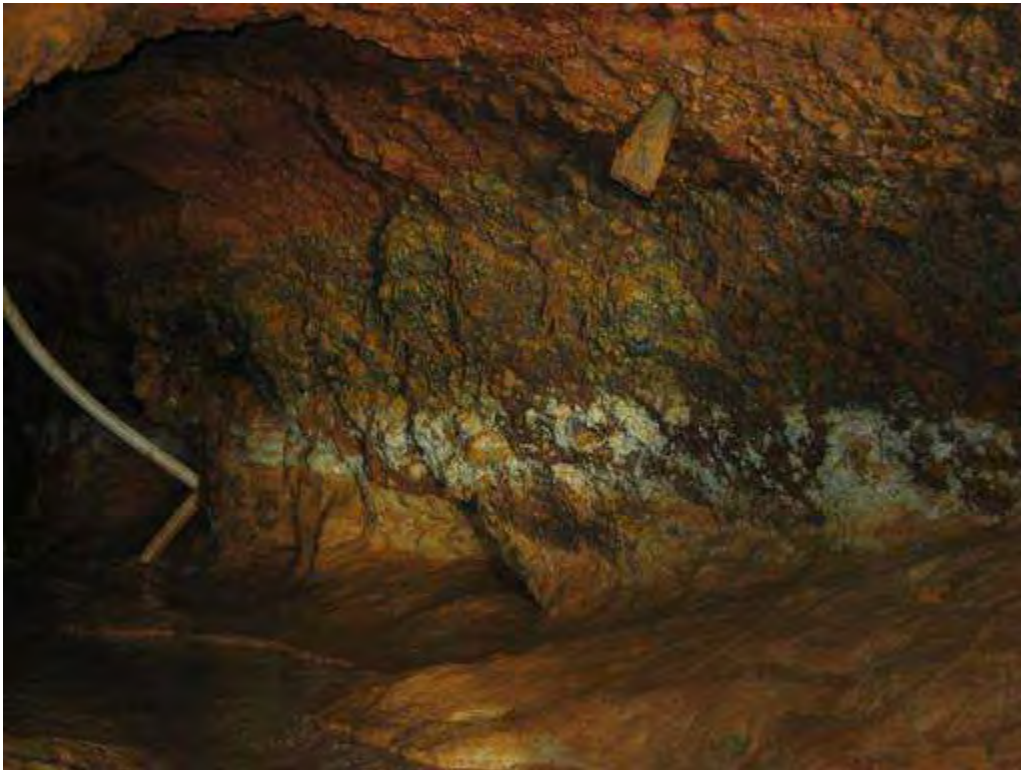
PHOTO 45 10-12-2011

Ferricrete walls inside the adit are stained red, orange, and white (Photo 45). The various colors are likely due to differing metals (likely predominantly iron and aluminum) dropping out of solution onto the rock walls. Apparent integrity of the adit seems to be very good as little collapse material could be discerned on the adit floor, and the adit walls and roof do not seem to be malformed from excessive caving.

Right rib of adit near portal showing various stained horizons on ferricrete formation. Orange-colored yellow boy fines on adit floor, light grey (aluminum hydroxide?) material on wall above yellow boy material, dark red iron oxide staining on back of adit. PVC well pipe in photo left, wood remnant wedge still intact in adit back.

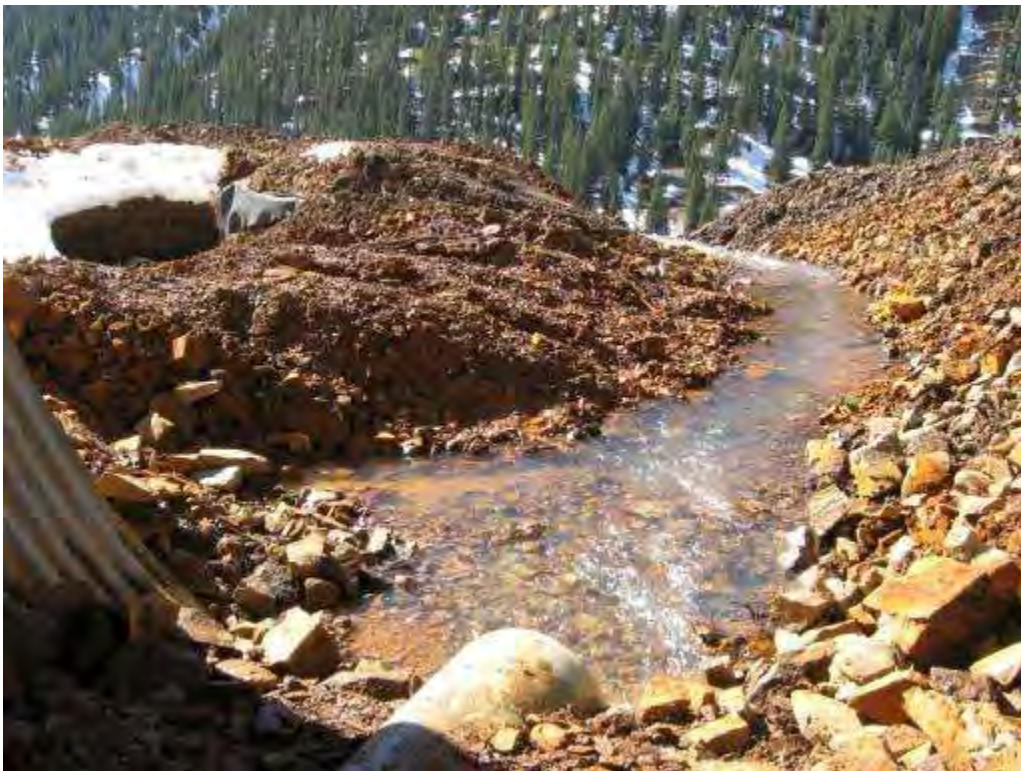
PHOTO 46 10-13-2011

AMD effluent from the adit via PVC pipe at the base of the portal structure. Water is directed to the flow location over the dump face that was in place prior to site activities.
